Irving Maine Woodlands – Fin Presentation

Asset Inventory Project

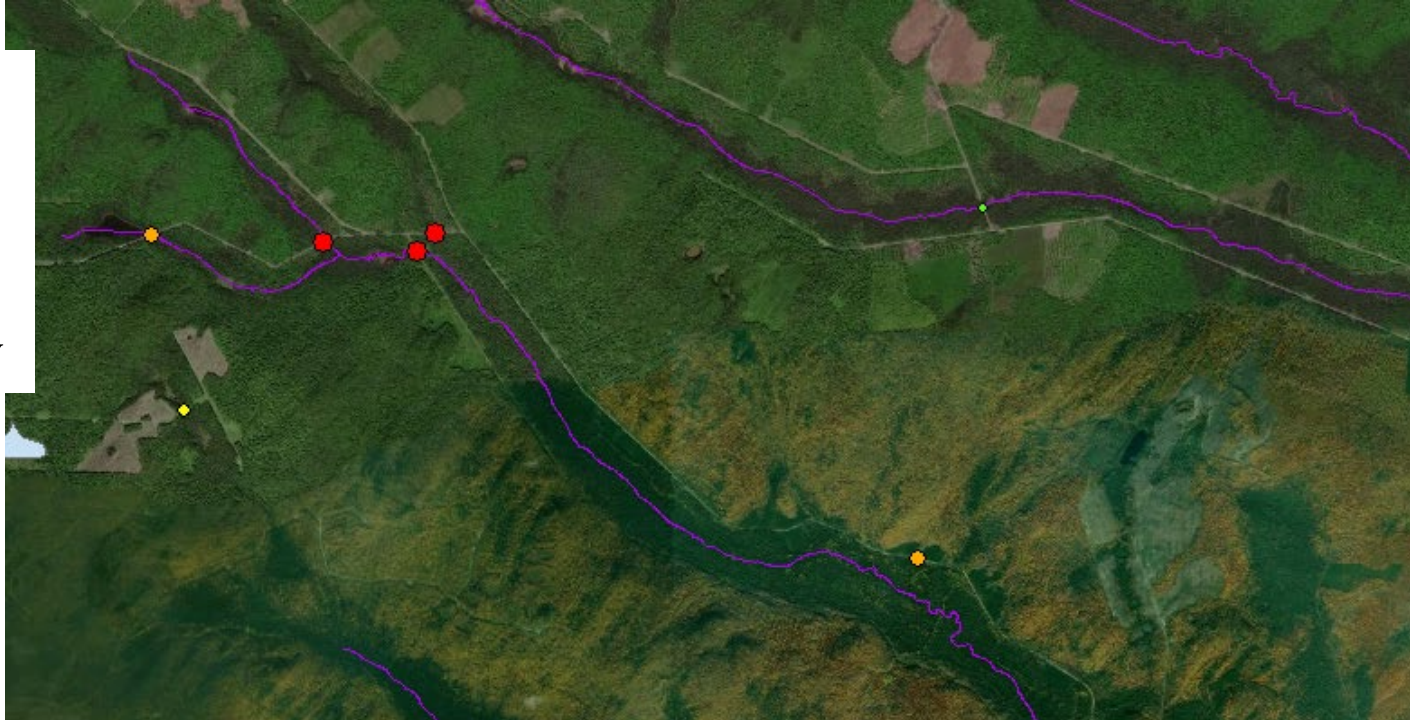
- Classified as Barrier.
- Perched.
- On stream ranked “Very High” priority habitat.

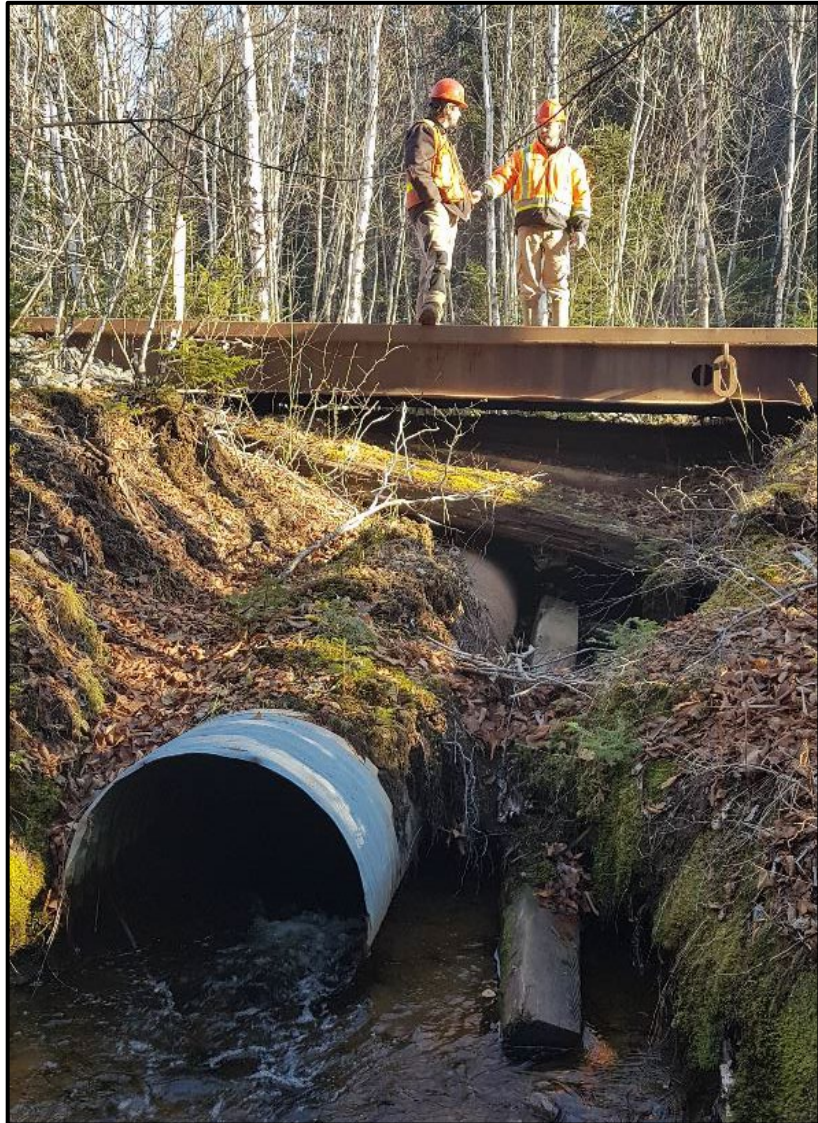
So what was the condition of our road crossing assets?

Similar to several studies, around 60% of watercourse crossing are a partial or complete barrier to fish passage.

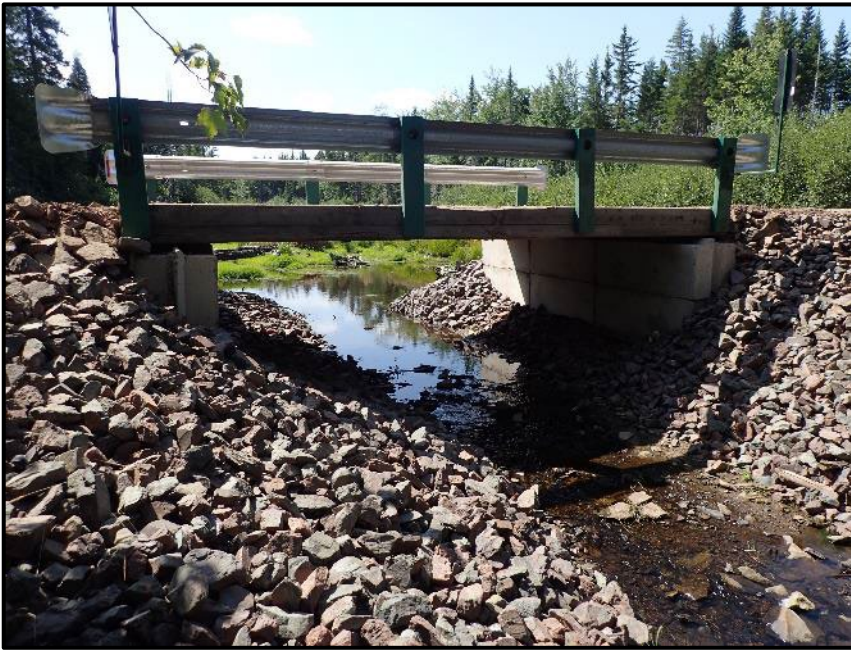
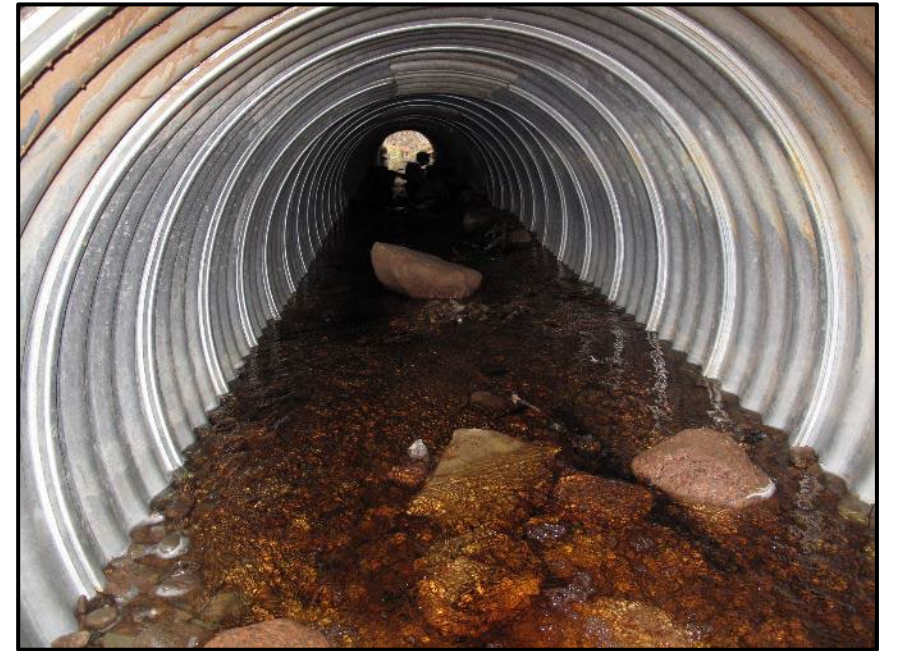
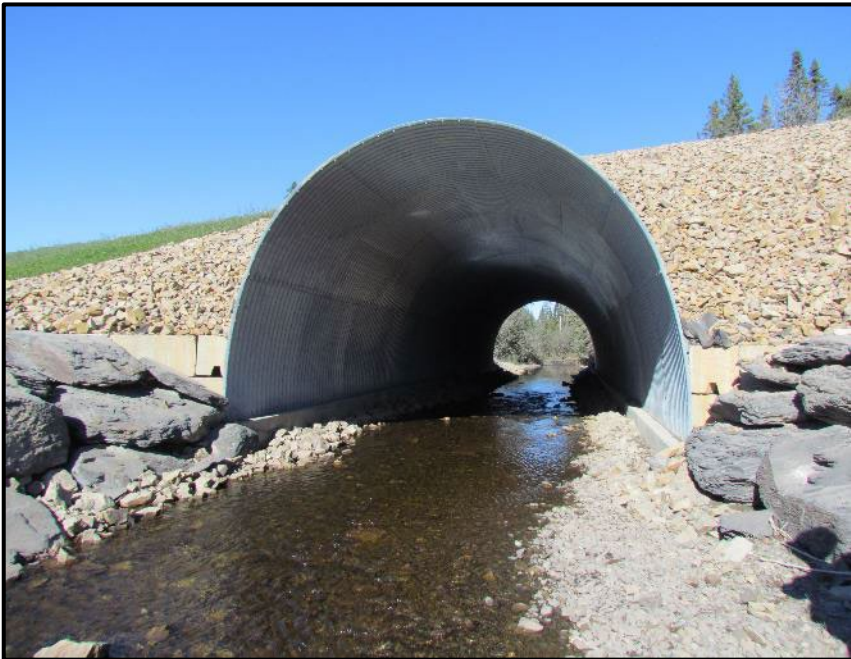
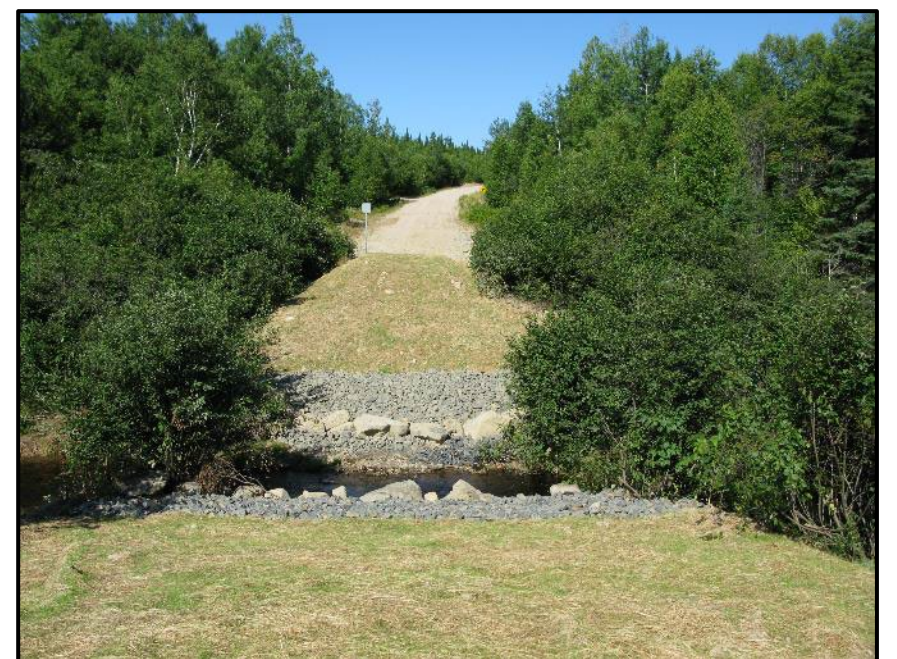
Preferred methods of restoring fish passage at problem sites would include bridges, arches, embedded and total removal.

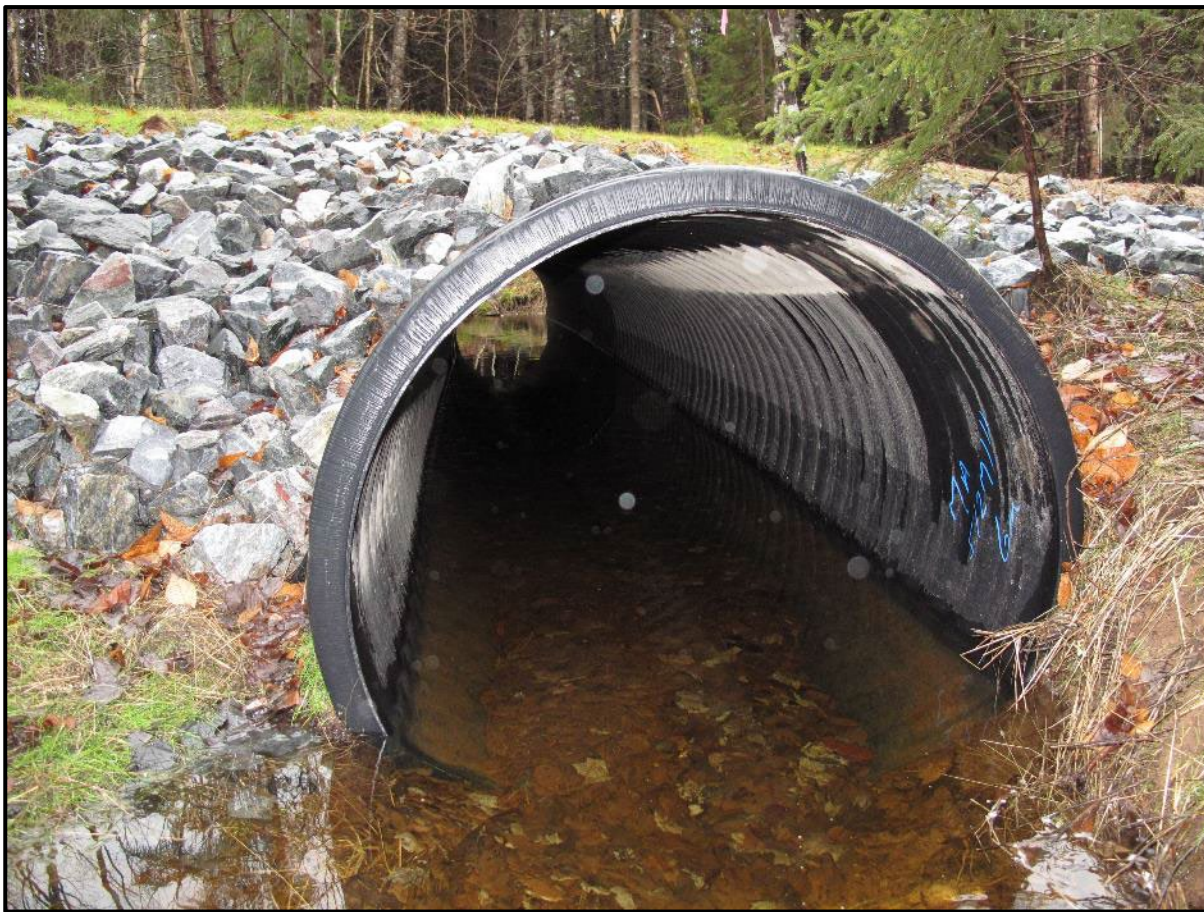
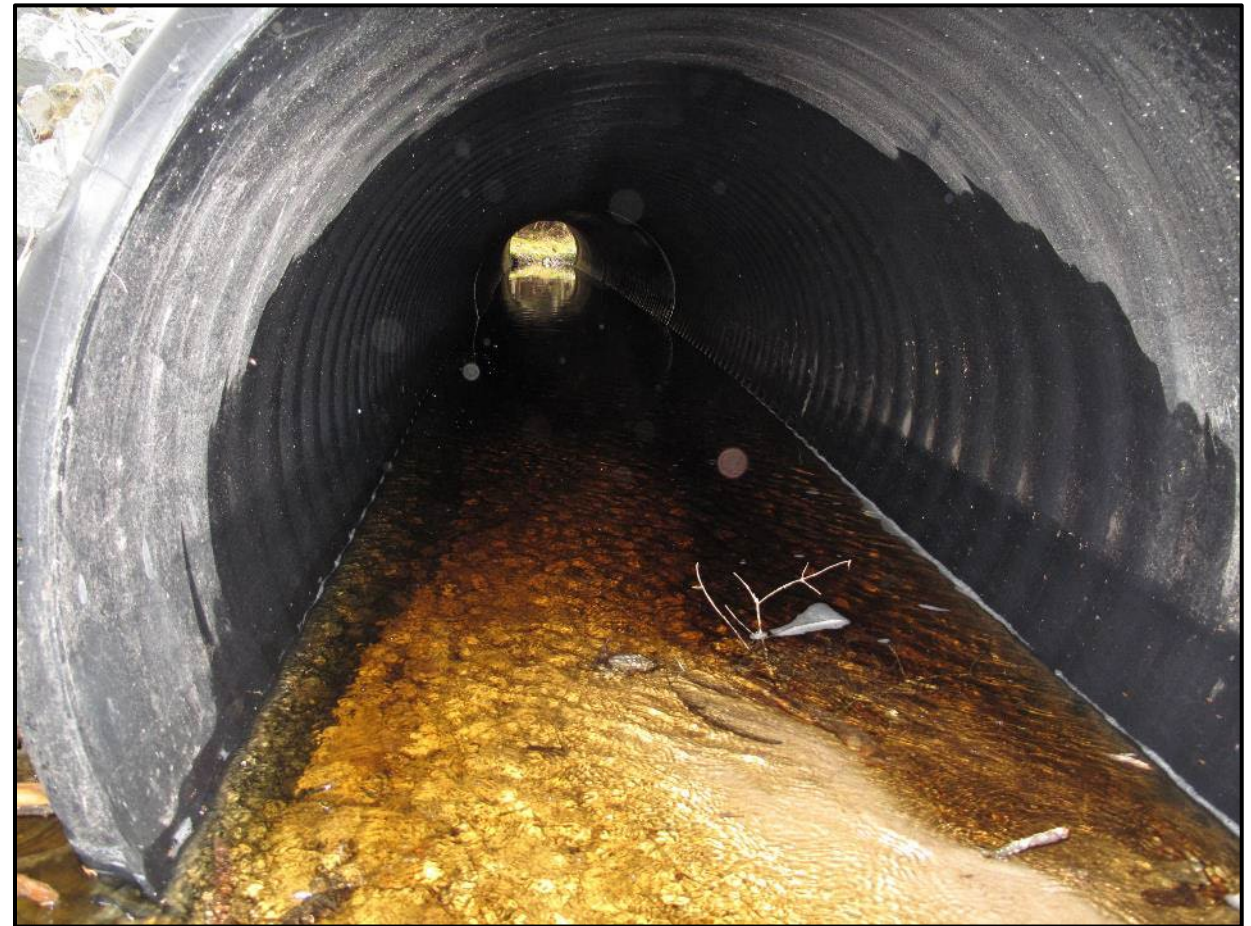
Round pipes, properly installed, should not be disregarded when considering options for fish passage improvement.
